### Wetland Delineation Report

June 1, 2023

**Revised: February 13, 2024**

**Re: Wetland Delineation Report  
Blue Rill Day Camp – 440 Saddle River Road  
Village of Airmont, Rockland County, NY**

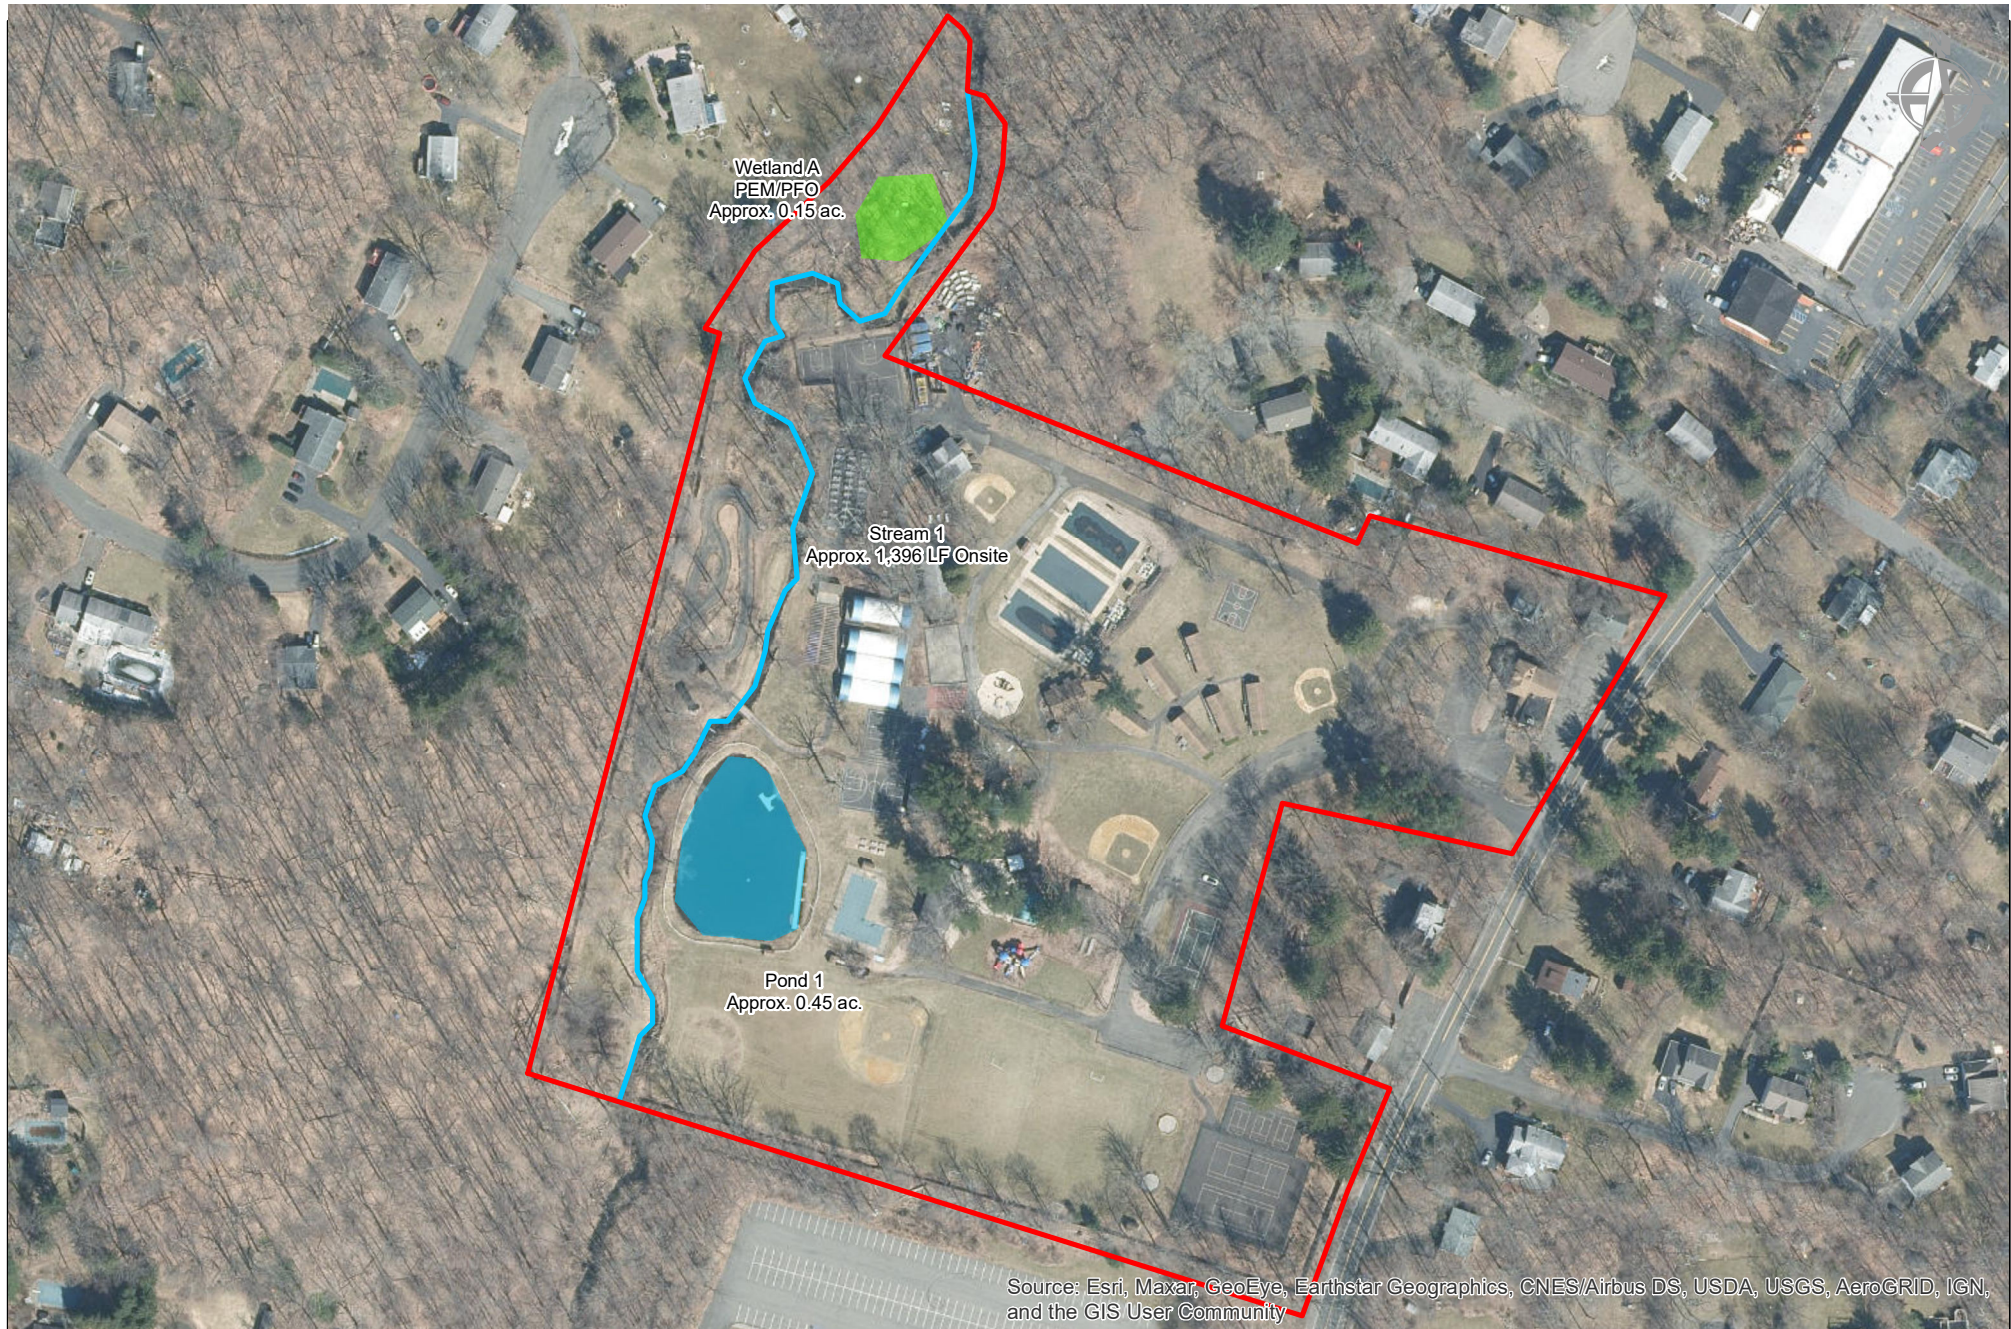
**FIGURE 3**  
**Wetland Delineation Map**

This wetland delineation effort resulted in the identification of one (1) wetland, one (1) stream, and one (1) pond. The resource boundaries are identified per the attached Figure 3. Ordinary High-Water Marks (OHWM), recorded as GPS points, were determined based on the presence of hydrology and stream bank characteristics.

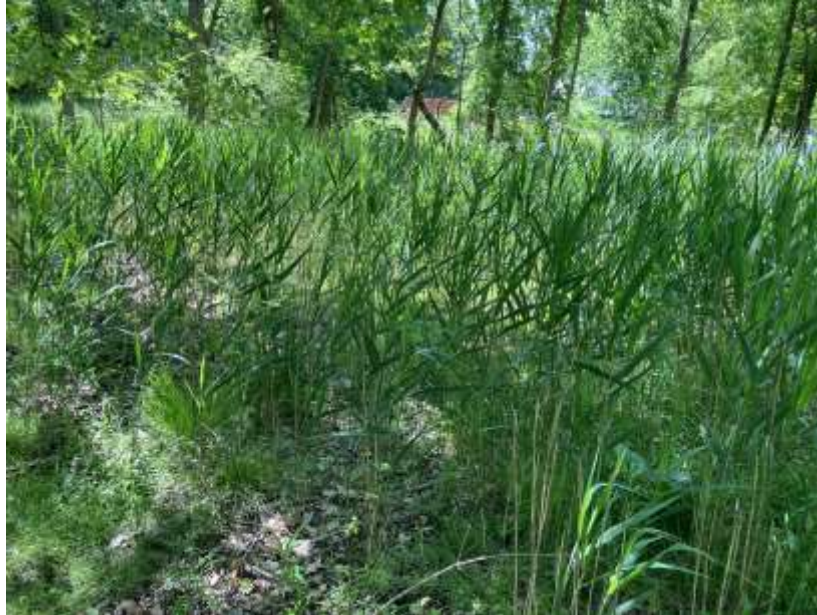
**Photo Number:** 2

Wetland A is a mixed palustrine emergent marsh and palustrine forested wetland (PEM/PFO) that covers approximately 0.15 acre (ac) at the northwest portion of the Subject Property. Wetland A is dominated by hydrophytic vegetation such as common reed (*Phragmites australis*) and red maple (*Acer rubrum*). Several indicators of hydrology were observed including presence of reduced iron and saturation. Hydric sandy loam soils were observed. Wetland A is adjacent to Stream 1; as such, Wetland A is under jurisdiction of the USACE.

**Photo Description:** Representative view of Wetland A.

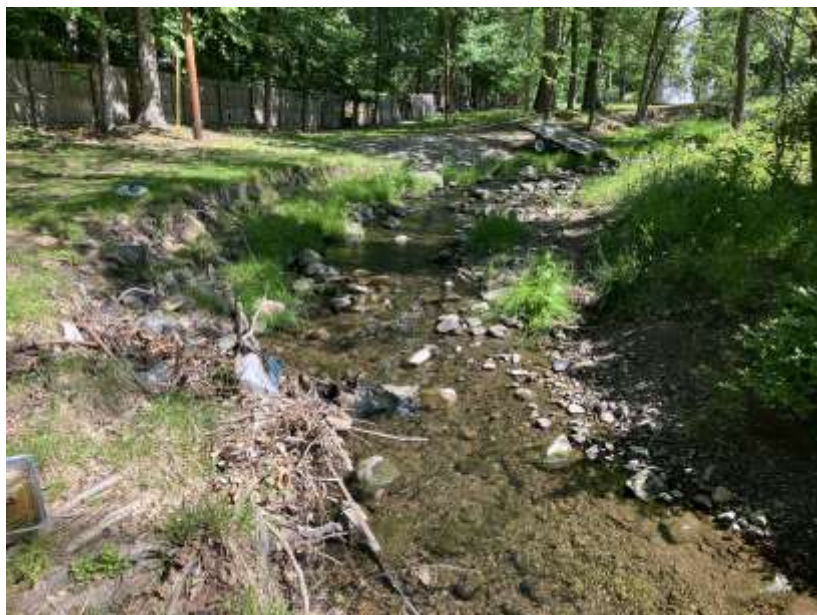
**Photo Number:** 3

Stream 1 is a perennial stream that flows south for approximately 1,396 linear feet (LF) onsite from the northwest corner of the Subject Property to where it flows offsite at the southwest corner. Stream 1 is approximately four (4) feet wide and six (6) inches deep at the OHWM with cobbles and gravel substrate. Stream 1 is mapped concurrently with Saddle River, a NYSDEC Class B (B) and Class C(C) freshwater stream. Portions of the stream mapped as a Class B(B) stream are under jurisdiction of the USACE and NYSDEC. Portions of the stream mapped as Class C(C) are under the jurisdiction of the USACE only.

**Photo Description:** Representative view of Stream 1.

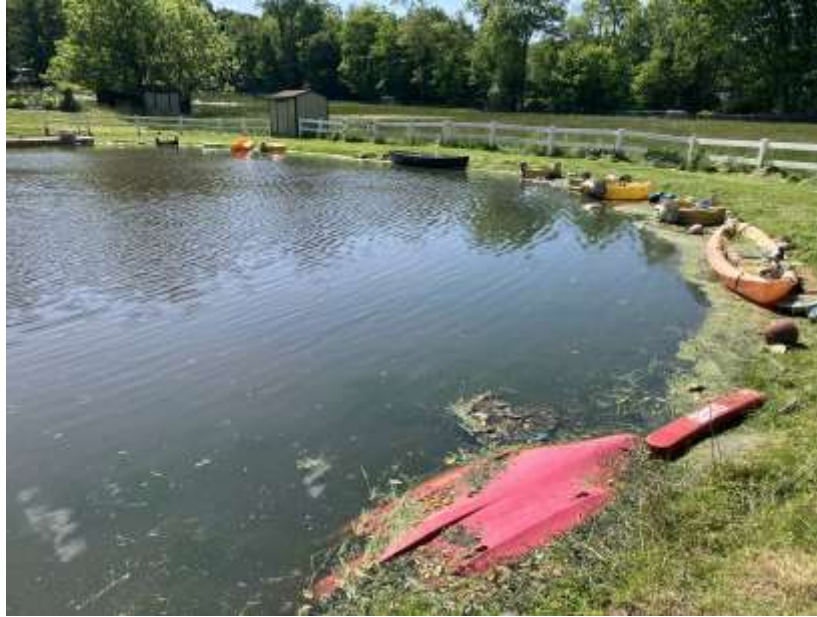
**Photo Number:** 4

Pond 1 is a 0.45 acre freshwater pond centrally located along the west border of the Subject Property. Pond 1 appeared to be multiple feet deep with mucky substrate at the time of delineation. One culvert is present along the west edge of the pond. However, the culvert is for highwater events in the pond and does not create a continuous connection between Pond 1 and Stream 1. Based on the August 2023 revision to the definition of WOTUS, Pond 1 is an isolated resource and not jurisdictional to the USACE.

**Photo Description:** Representative view of Pond 1.

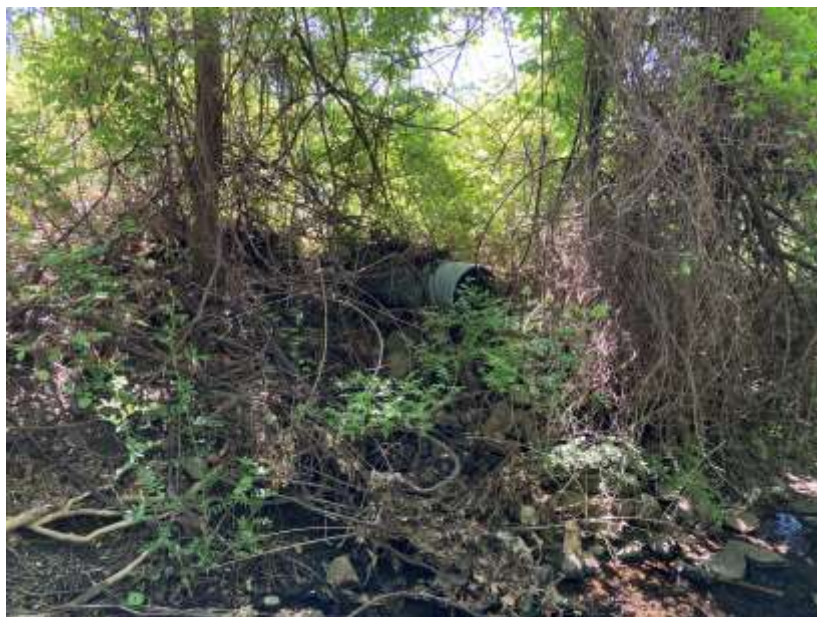
**Photo Number:** 5

**Photo Description:** Culvert connecting Pond 1 to Stream 1.

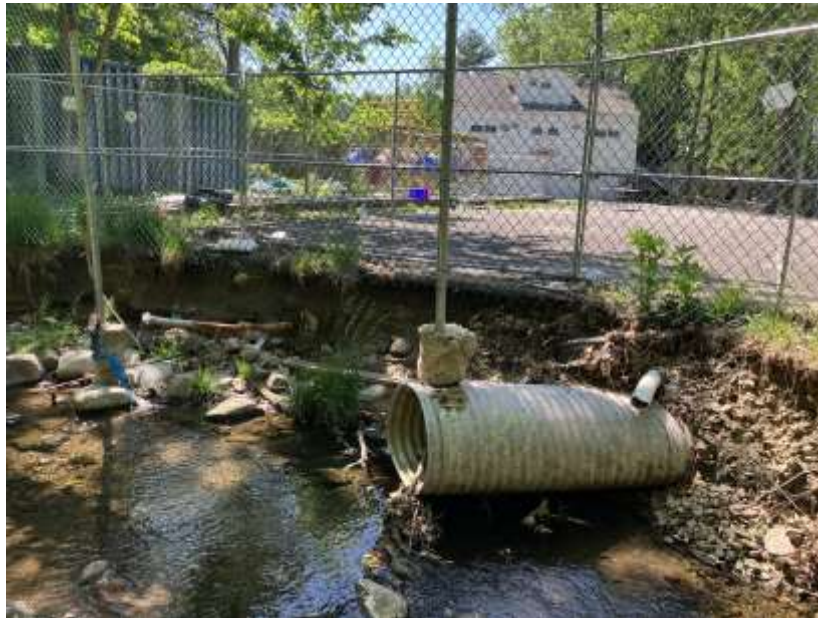
**Photo Number:** 6

**Photo Description:** Culvert beneath basketball court connecting to Stream 1.

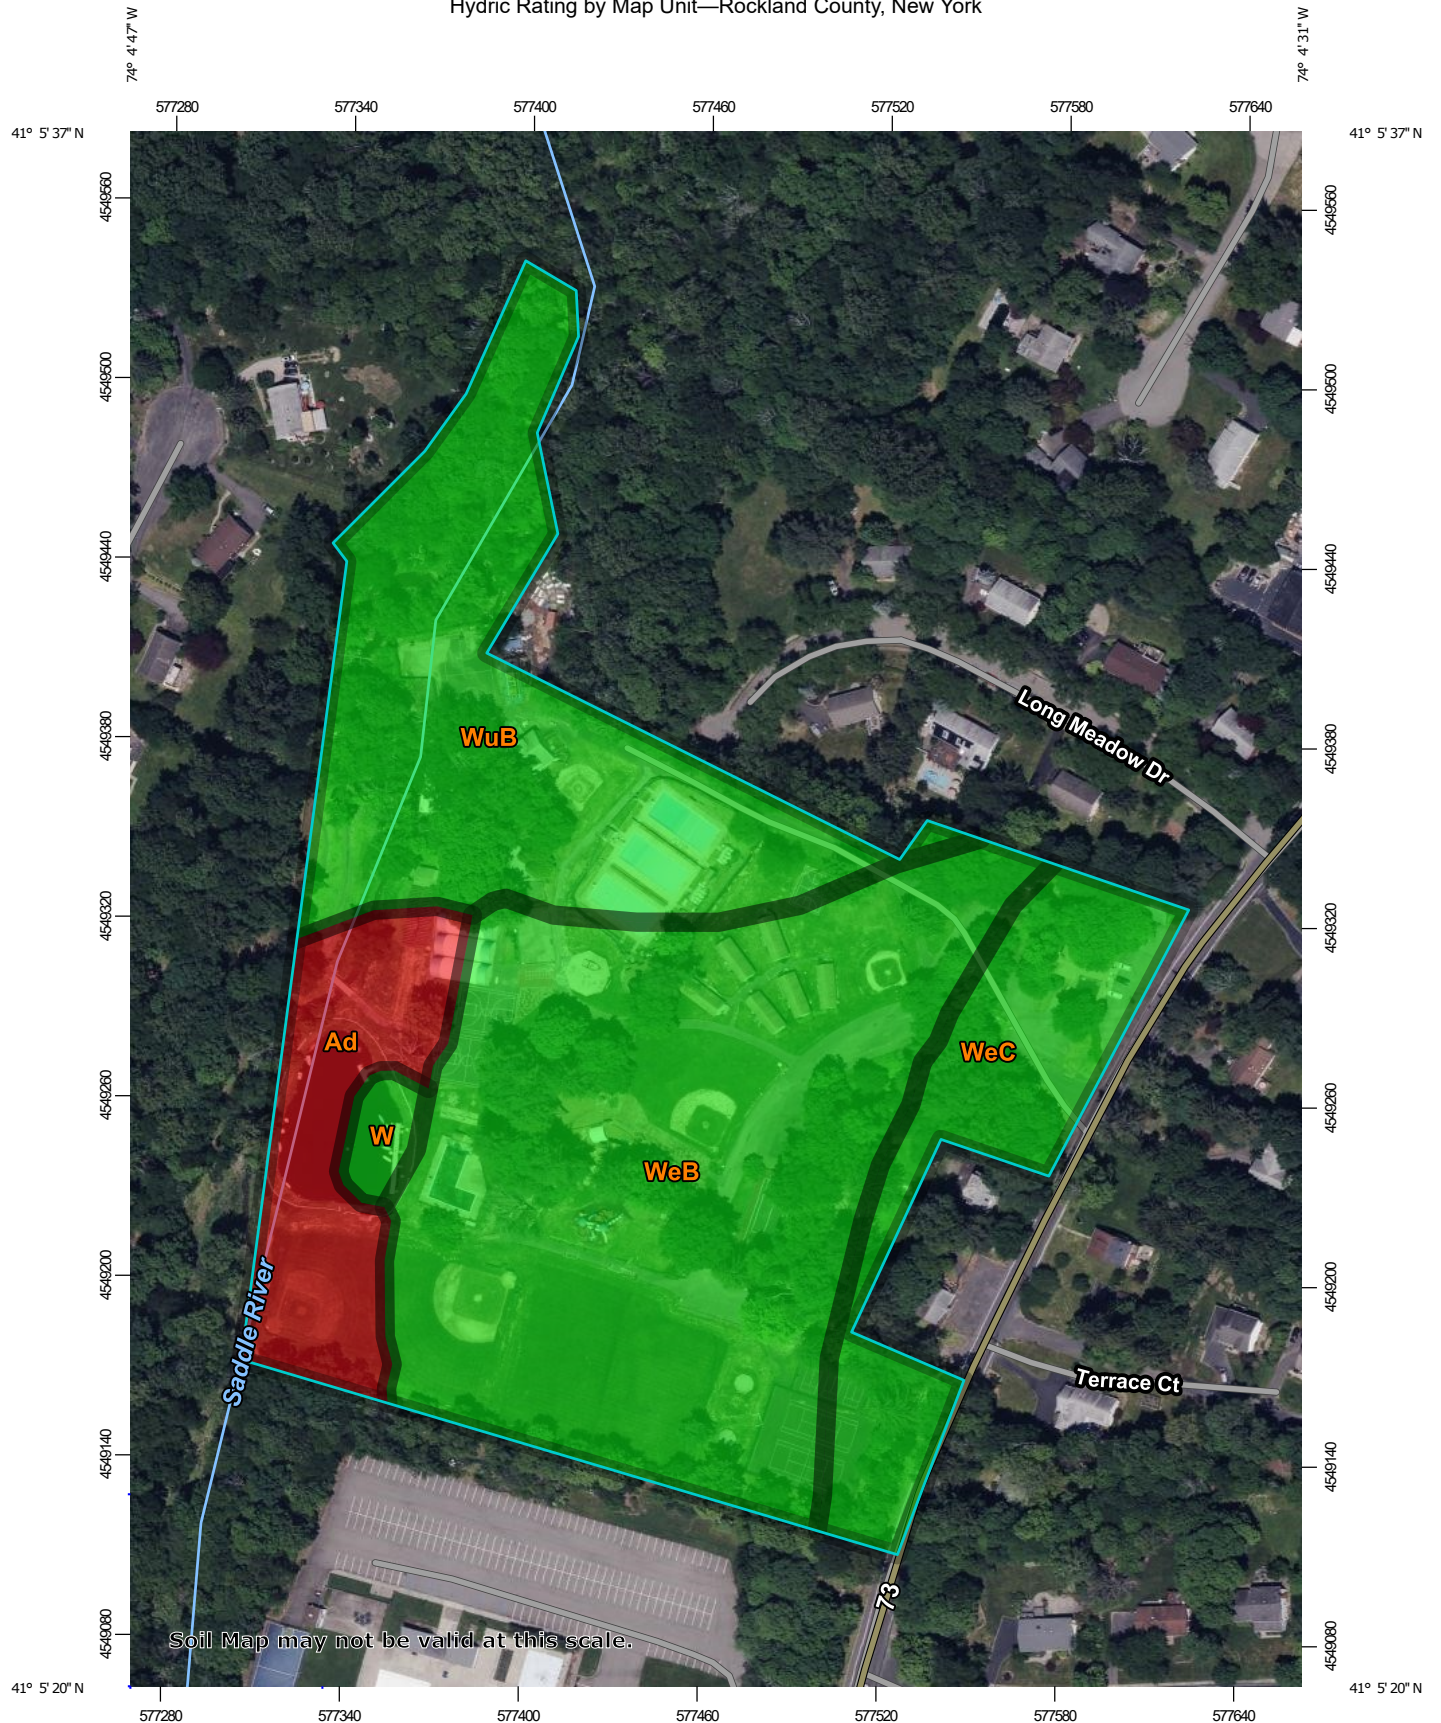
# Hydric Rating by Map Unit—Rockland County, New York

The county soil survey shows that the site contains the following mapped soils: Alden silt loam (Ad), Wethersfield gravelly silt loam, three-to-eight percent slopes (WeB), Wethersfield gravelly silt loam, eight-to-15 percent slopes (WeC), and Wethersfield-Urban land complex, two-to-eight percent slopes (WuB). Soil map unit WeB is considered prime farmland and soil map unit WeC is considered farmland of statewide importance. Soil map units WeB, WeC, and WuB are classified as well drained soils, soil map unit Ad is classified as very poorly drained soils. Soil map unit is the only soil classified as a hydric soil, with a hydric soil rating of 100% (see attached Hydric Soil Rating Map).

The thematic map is color coded based on the composition of hydric components. The five color classes are separated as 100 percent hydric components, 66 to 99 percent hydric components, 33 to 65 percent hydric components, 1 to 32 percent hydric components, and less than one percent hydric components.
